The fire resistance performance of a single leaf single acting doorset, when tested in accordance with BS EN 1634-1: 2014 and BS EN 1363-1: 2012

WF 391562

Astra Door Controls Ltd

An unlatched single leaf single acting doorset

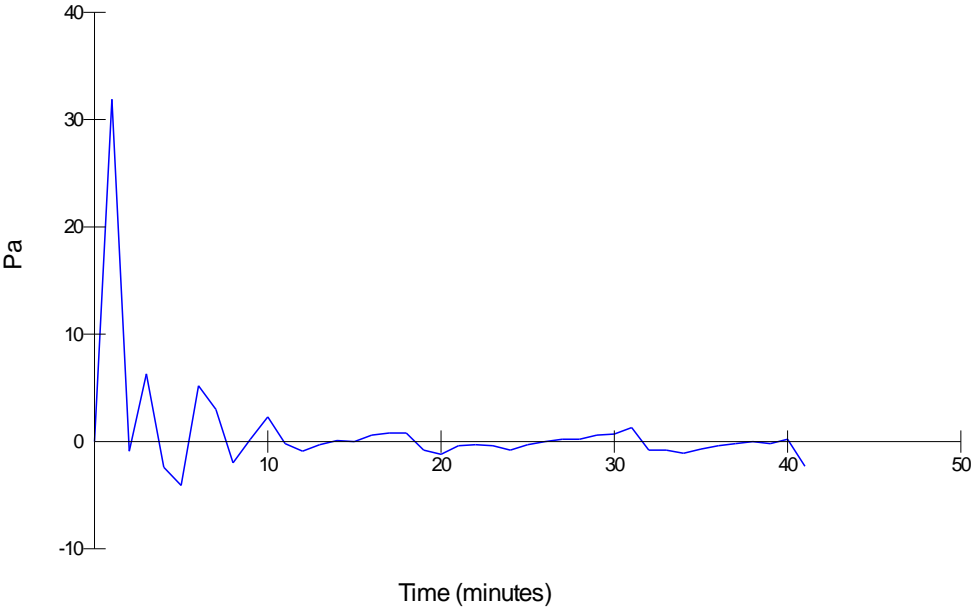
After the first 5 minutes of the test, the furnace pressure was maintained at 0 ± 5 Pa and after 10 minutes was maintained at 0 ± 3 Pa with respect to atmosphere, at a point 0.5m from the notional floor level. The pressure readings were recorded and are shown graphically below:

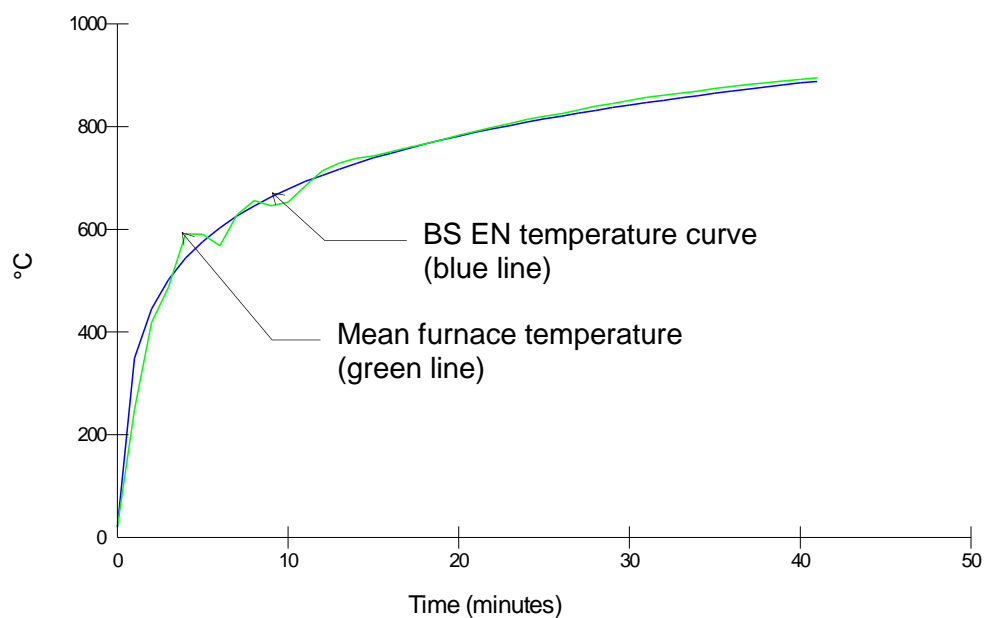
The furnace was controlled to follow the temperature/time relationship specified in BS EN 1363: Part 1: 2012 Section 5.1.1 as closely as possible, using the average of nine plate thermometers suitably distributed within the furnace. The temperatures were recorded and are shown graphically below:

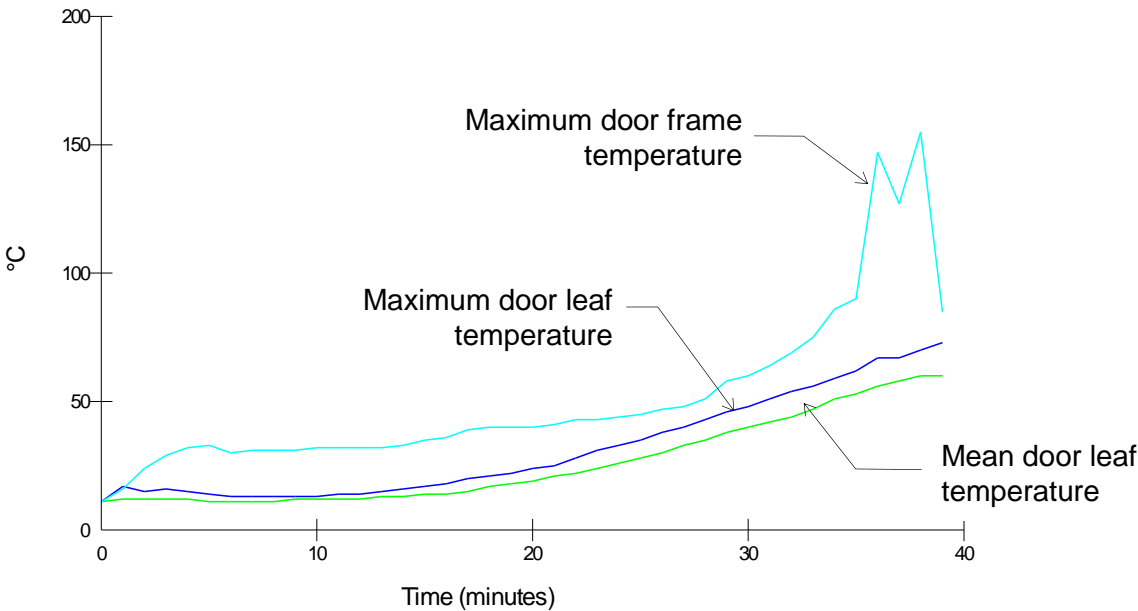
Unexposed face temperature curves

1 discrete area	
Leaf	Discrete area (timber)	5 measuring mean temperature rise. 4 measuring maximum temperature rise, standard set 100mm in from the door leaf edges.
Frame		5 measuring maximum temperature

The locations of the thermocouples are shown in Figure 6 of Appendix 1. The temperatures were recorded and tabulated in Appendix 2 and are shown graphically below:

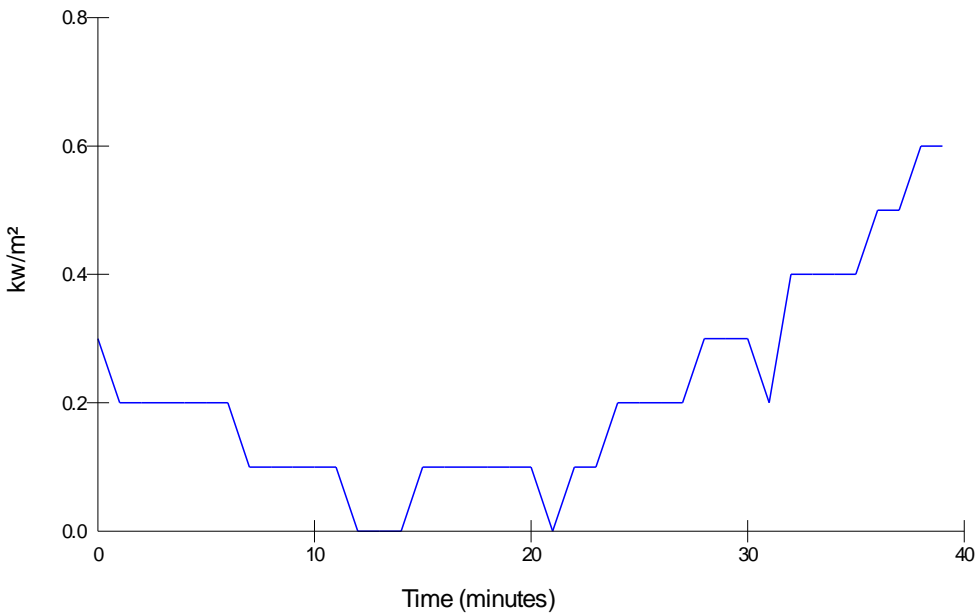
A radiometer was used to measure the radiation 1m away from the specimen. The results of the radiometer were recorded and are shown graphically below:

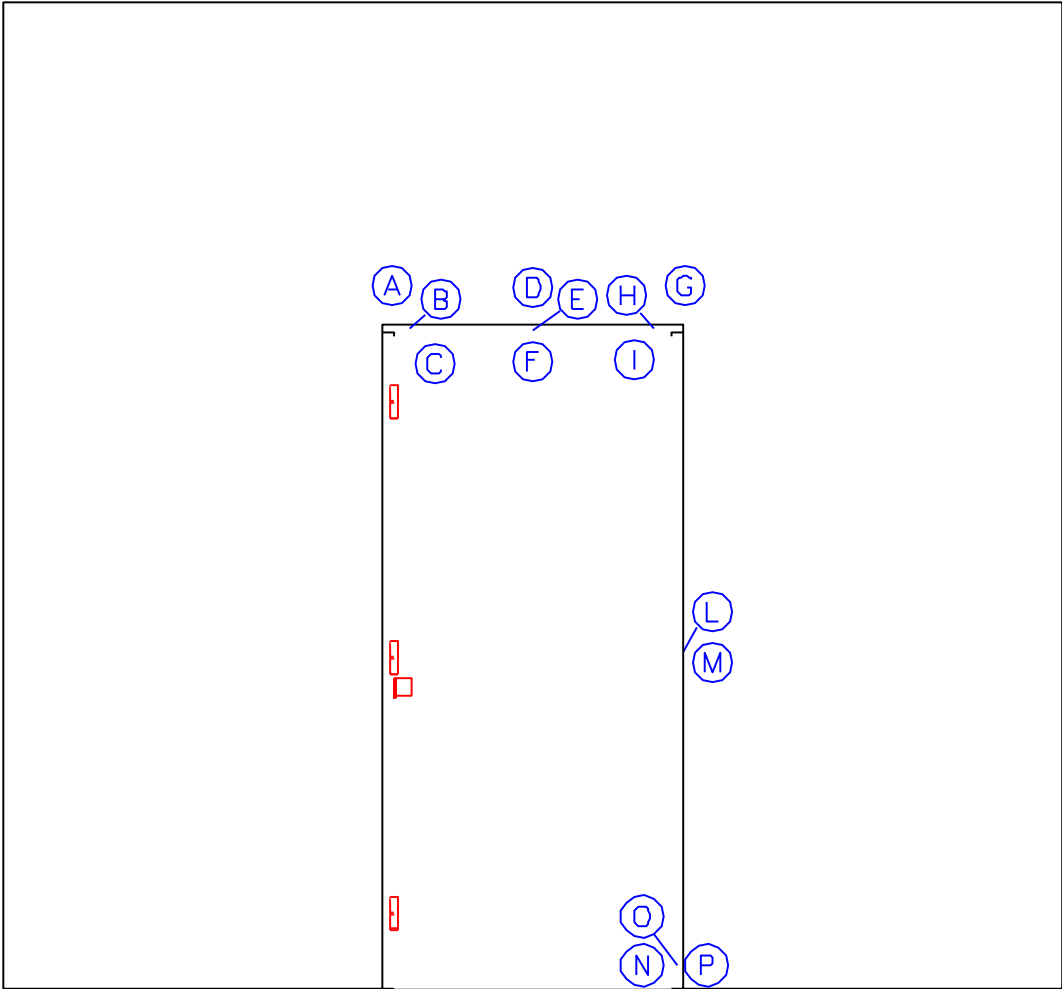
The following tables show the distortion in mm with an accuracy of ± 1 mm.
A positive measurement indicates distortion towards the furnace.
A negative measurement indicates distortion away from the furnace.

Leaf - hung on the left and opening in towards the furnace

Time	A	B	C	D	E	F	G	H	I	J	K	L	M	N	O	P
10	12	11	9	10	12	11	11	10	11	9	9	11	10	8	7	8
20	24	25	24	28	29	31	32	34	35	19	24	24	26	14	10	8
30	32	35	35	44	43	42	47	50	54	17	32	36	35	16	11	9

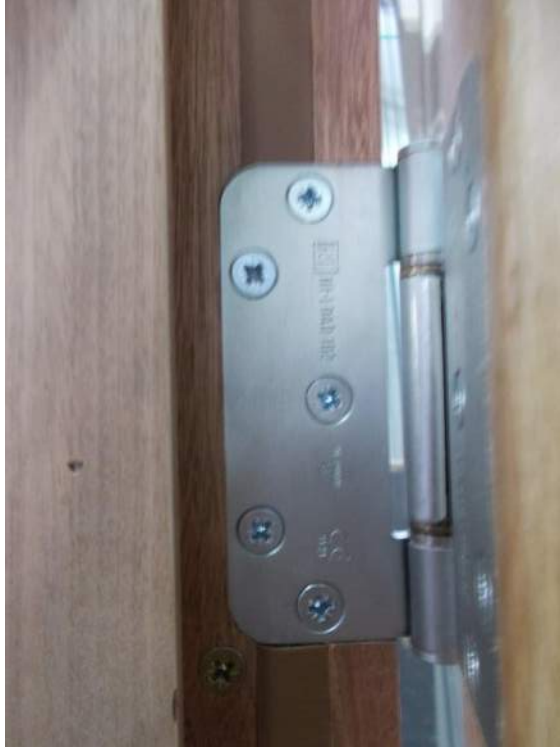
Intumescent interruptions by hardware and additional intumescent protection

Around hinge blade

Make/type	Size (mm)	Location
Around hinge blade	Fully interrupted	-	Hinge blade fully interrupts seal in the frame reveal
Under hinge blades	None fitted	-	-
Around closer reaction plate	Fully interrupted	-	Closer reaction plate fully interrupts seal in frame reveal
Under closer reaction plate	None fitted	-	-

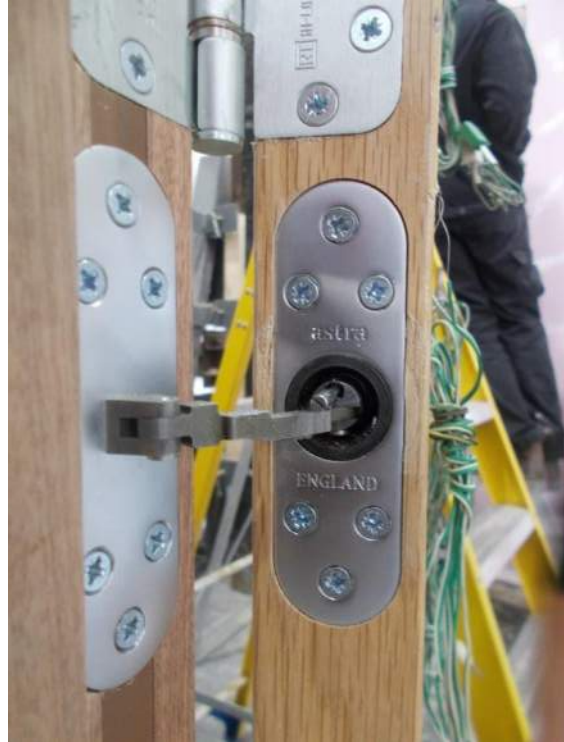
Around closer reaction plate

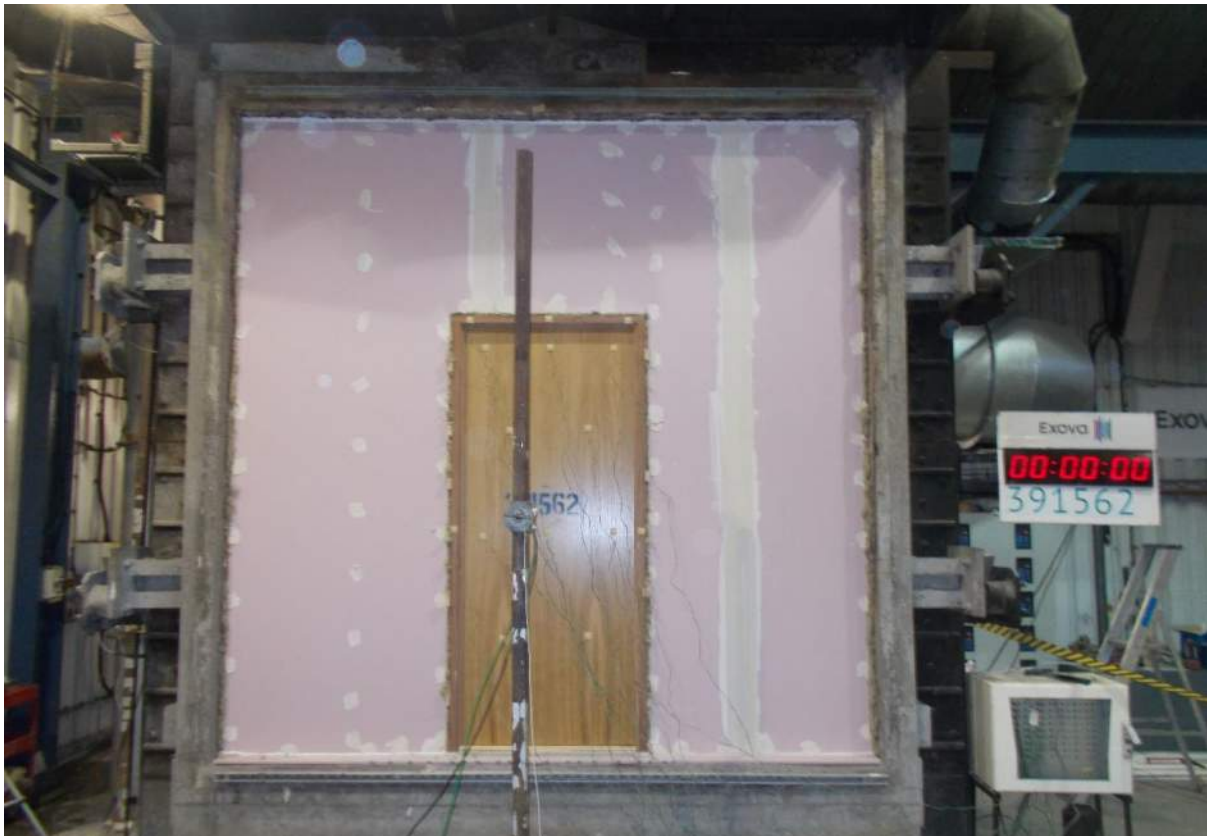
At start of test

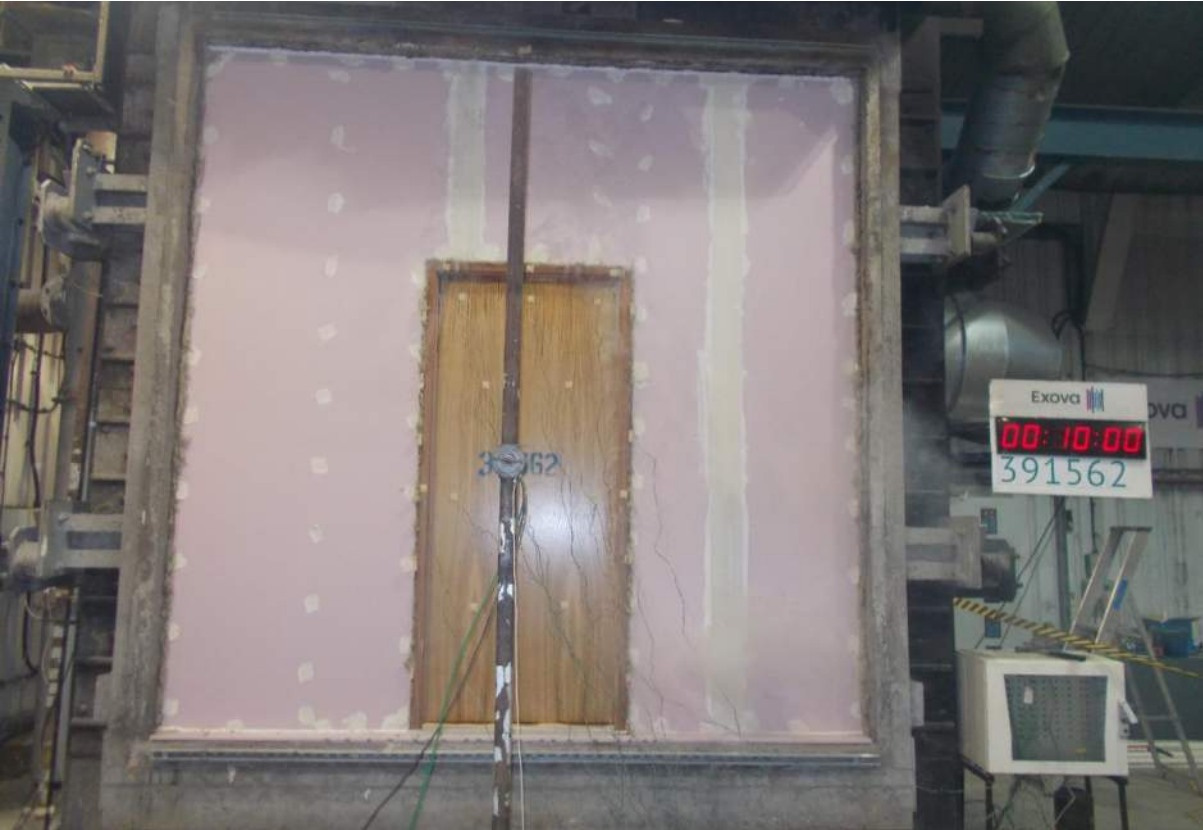
At 10 minutes

04:12	There is smoke issuing at the top half of the closing edge.
05:52	There is discolouration at the top hinge position.
11:15	Exposed face, the veneer has fallen away, fissures approximately 3-4mm on the leaf.

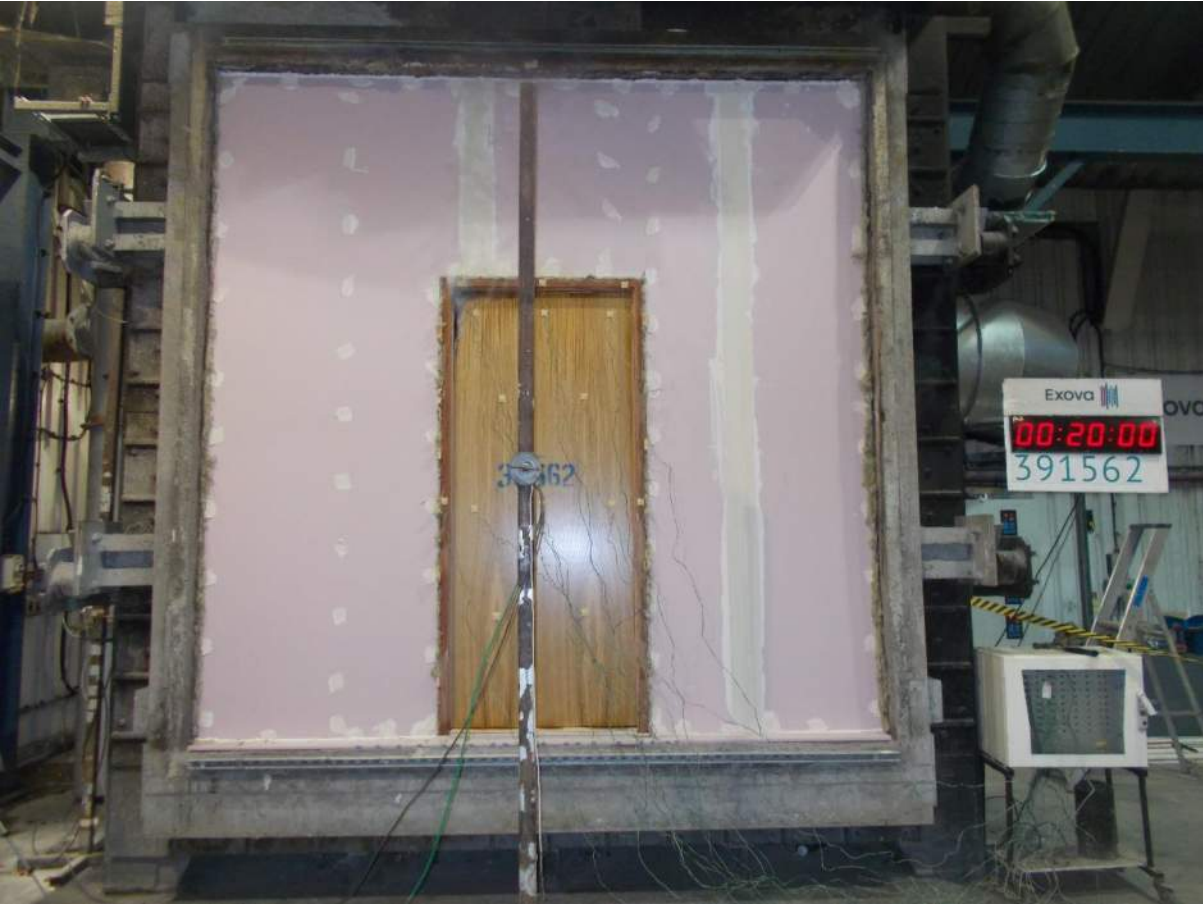
At 20 minutes

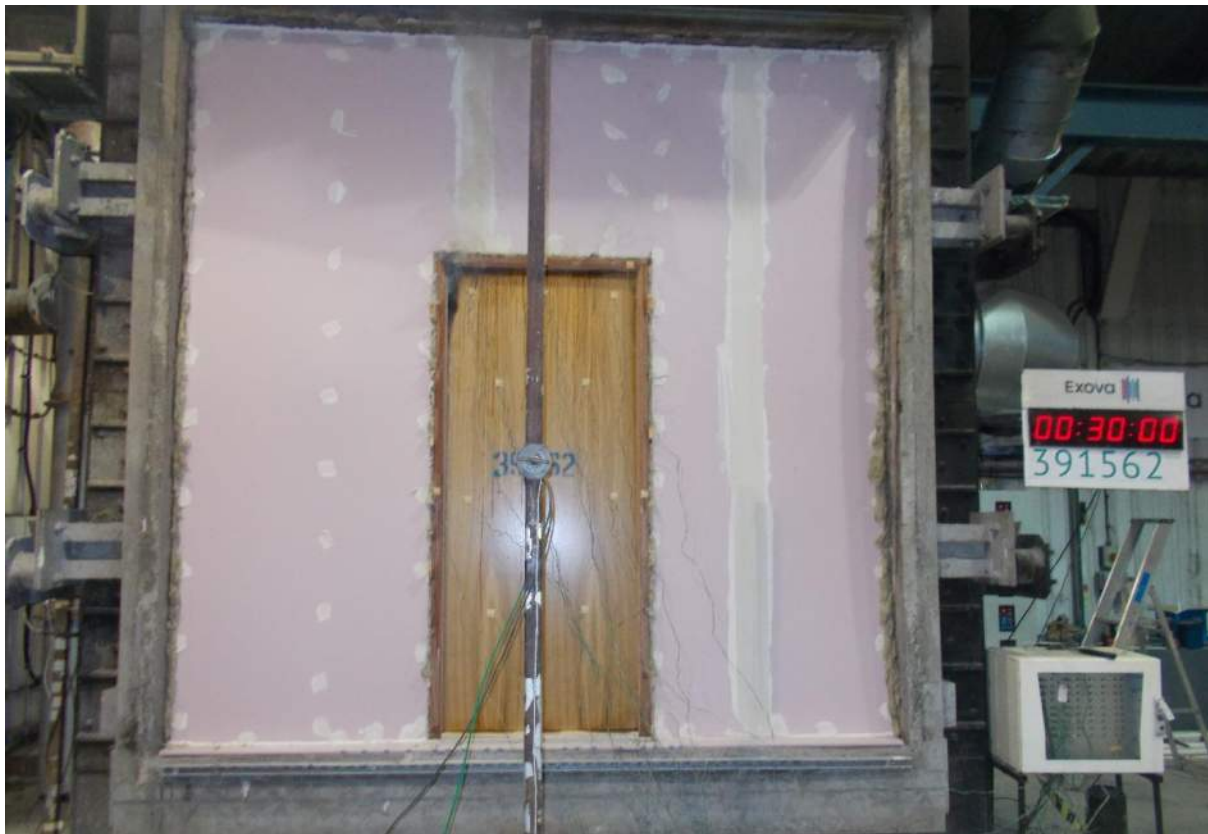
At 30 minutes

27:03	There is a glow visible at the top hinge position.
29:10	A cotton pad integrity test was performed at the top hinge position which did not result in the ignition of the cotton pad. No failure.

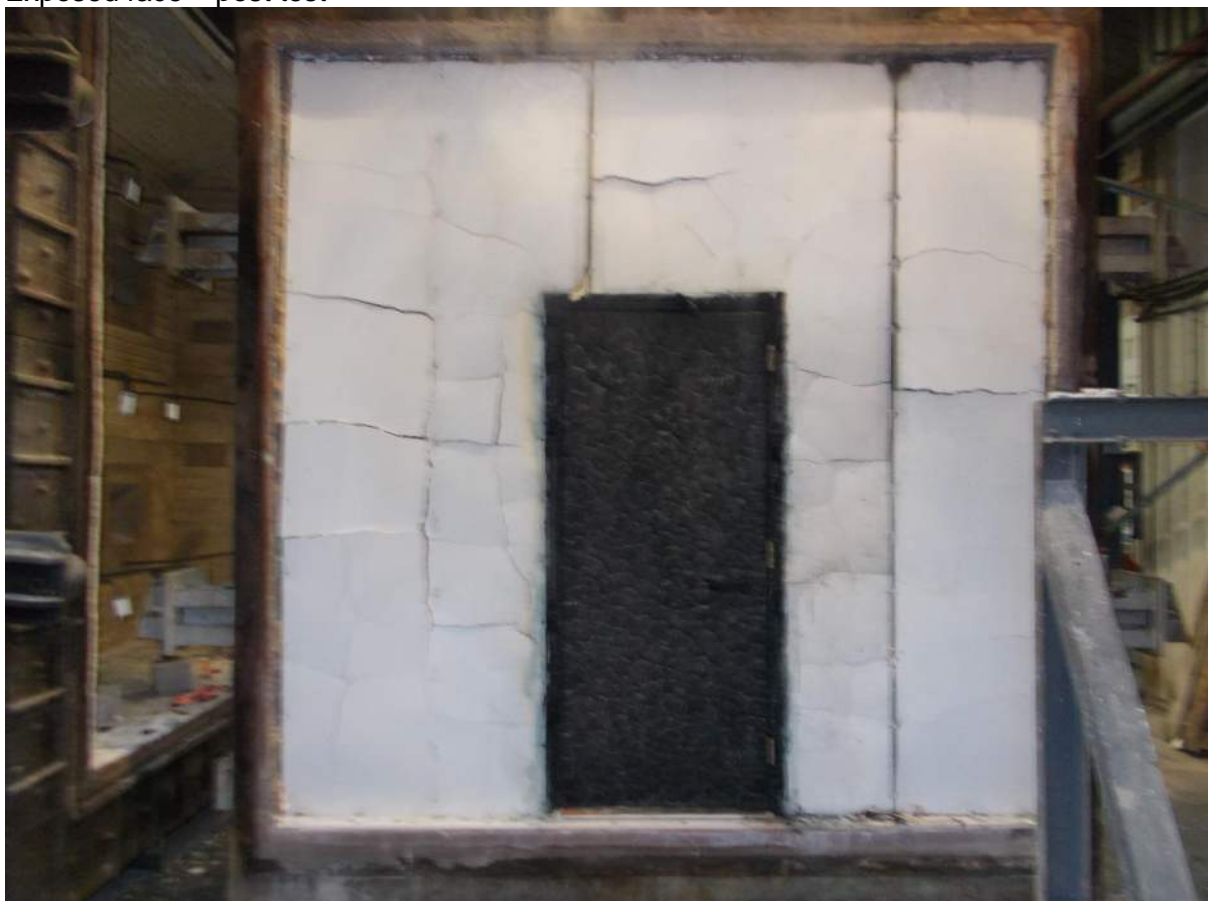
Exposed face – post test

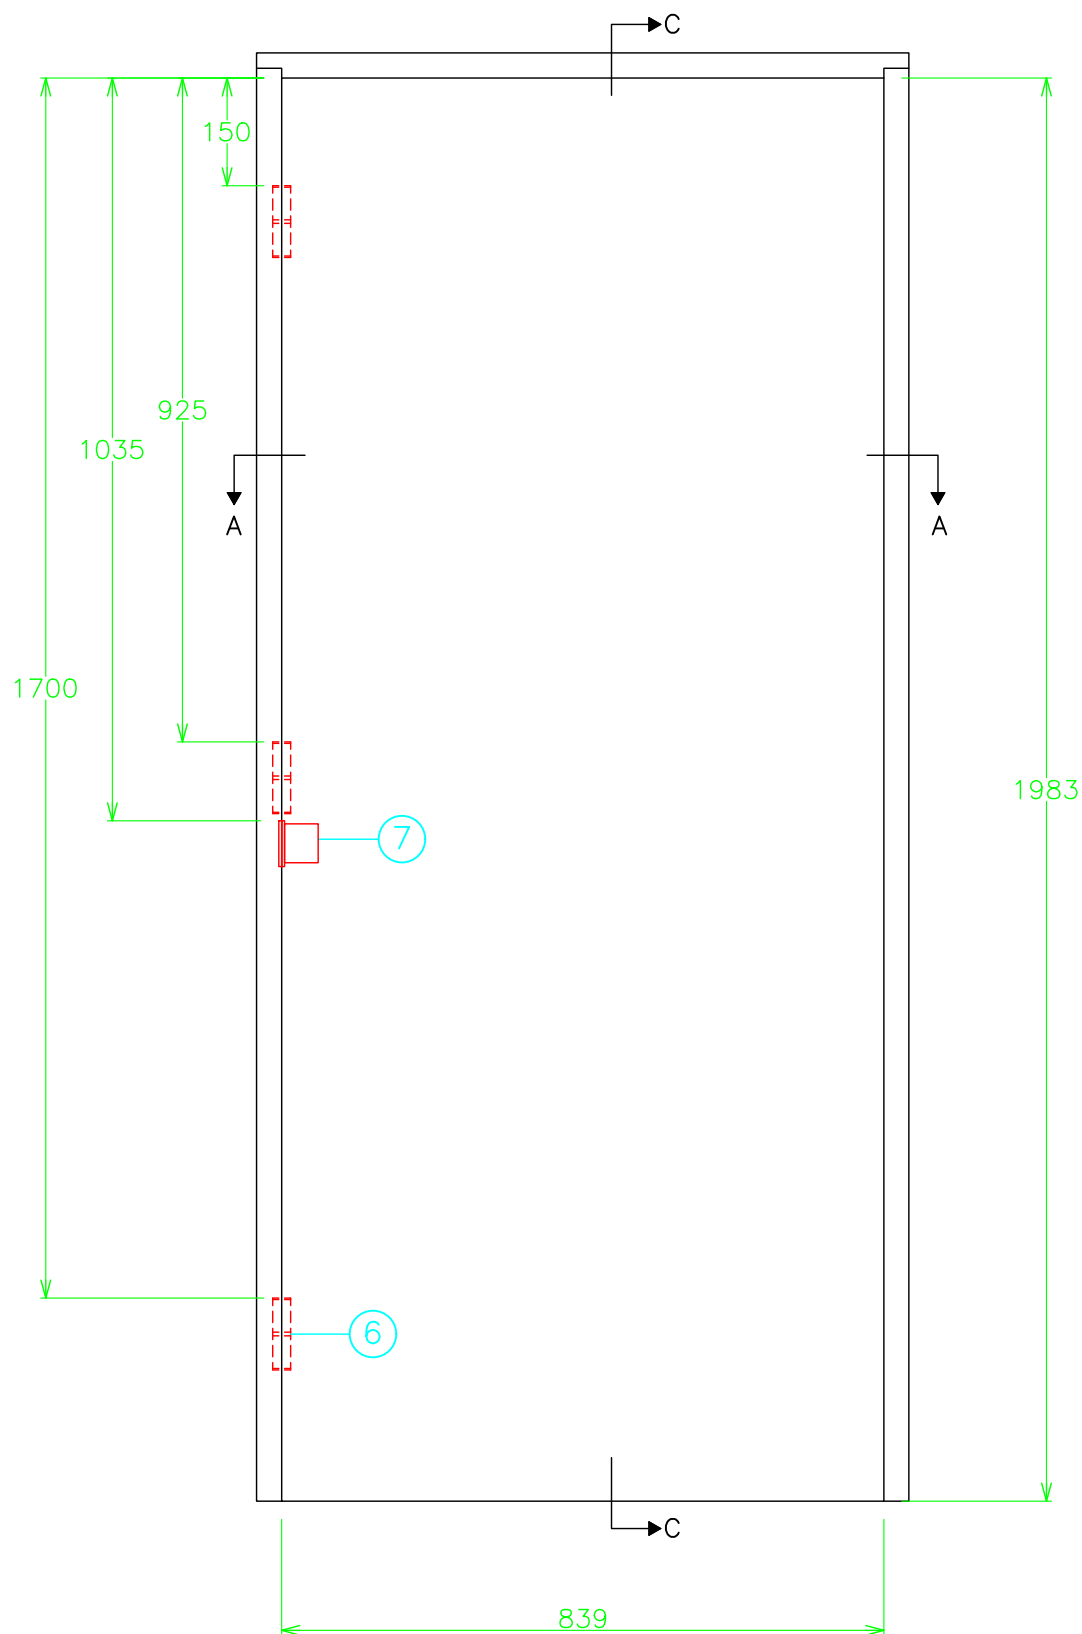
Title Unexposed face elevation
showing hardware positions
(All dimensions in mm)

Make/type	Size (mm)	Location	Key to figures
Hinges	3No. Royde and Tucker Hi-Load 101 stainless steel bearing butt type hinge fixed with 5No. 31mm long screws per blade	100 x 34 x 3 (blade size)	Fitted 150mm, 925mm and 1700mm from the head of the leaf	6
Closer	Astra Door Controls Ltd jamb acting concealed closer Ref: AST 4000 series*	110 x 32 (forend size)	Fitted 1035mm from the head of the leaf	7
Latch	None fitted	-	-	-
Furniture	None fitted	-	-	-

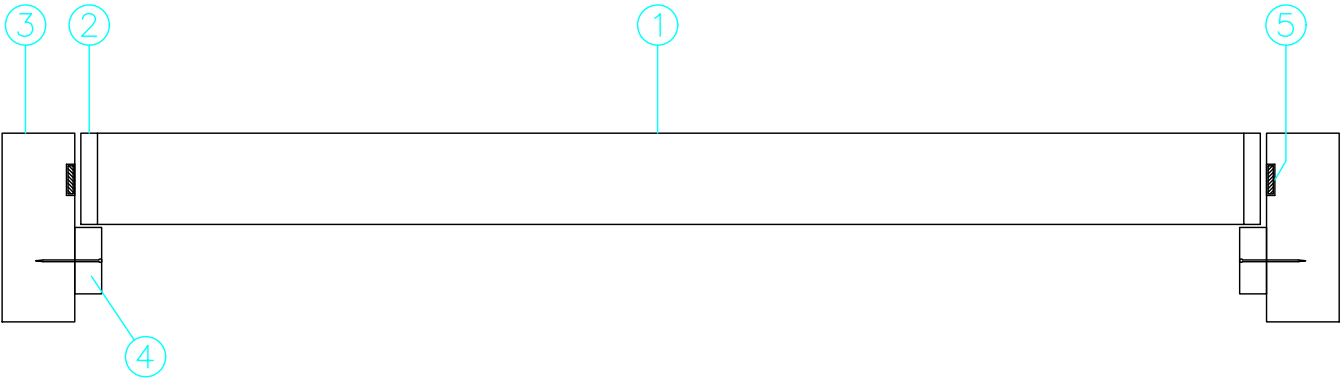
Section A-A

Horizontal cross sections
(All dimensions in mm)

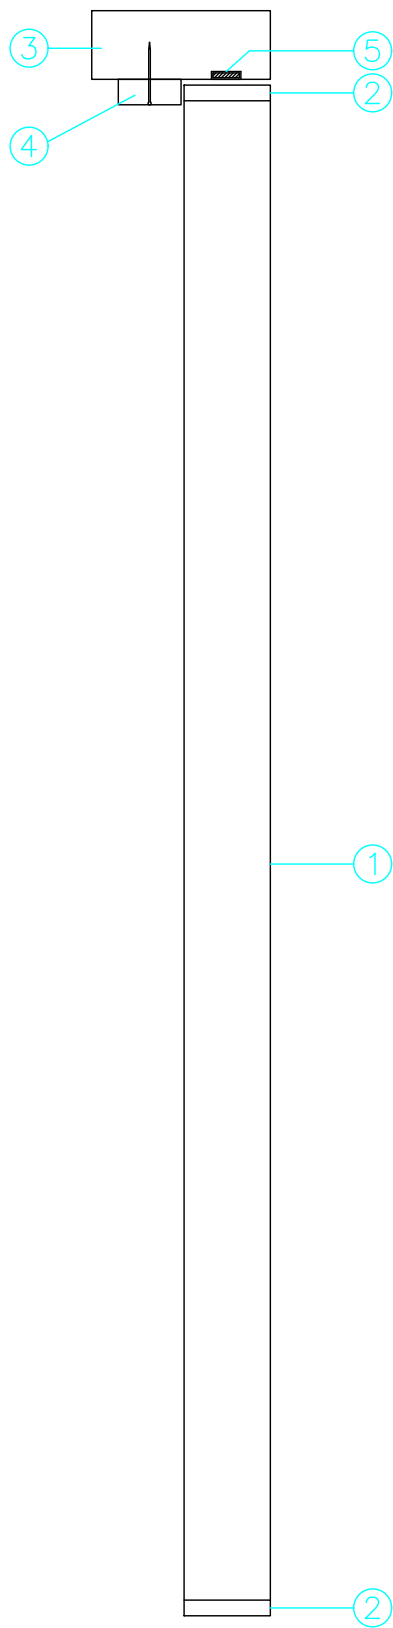
Section B-B

Title		
Vertical cross section		
(All dimensions in mm)		
Date Drawn	Drawn By	Scale
16/11/17	ARD	NTS
Project No.		Appendix 1
WF 391562

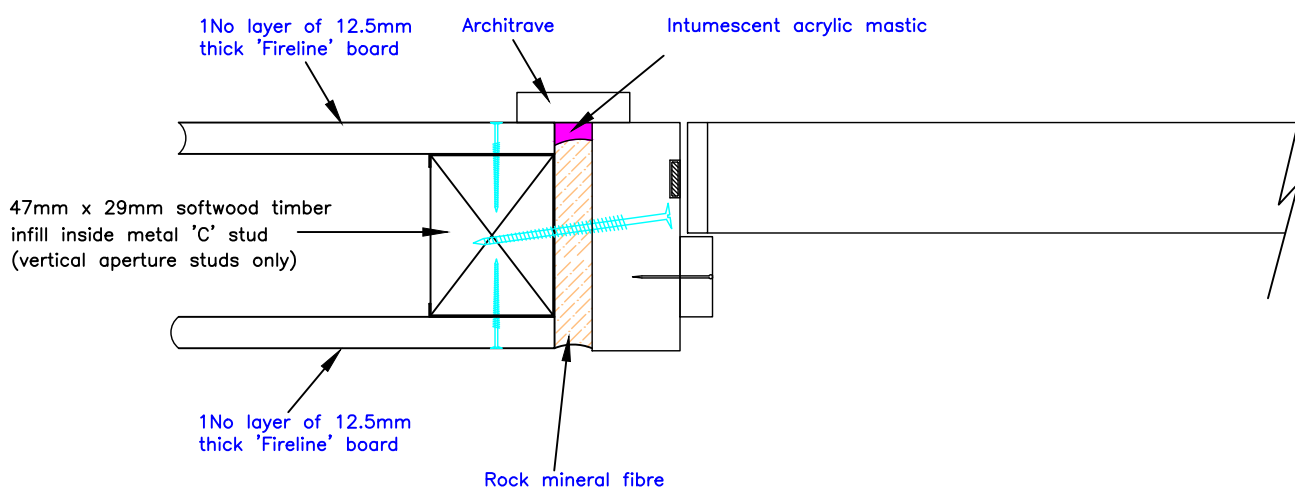
Title
Frame to supporting construction
fixing detail
(All dimensions in mm)

The doorset was fixed into a pre-prepared opening. The details of the fixings and fire stopping between frame and supporting construction are outlined in the construction section and Figure 4 of Appendix 1. The exposed face of the doorset was flush with the exposed face of the supporting construction.

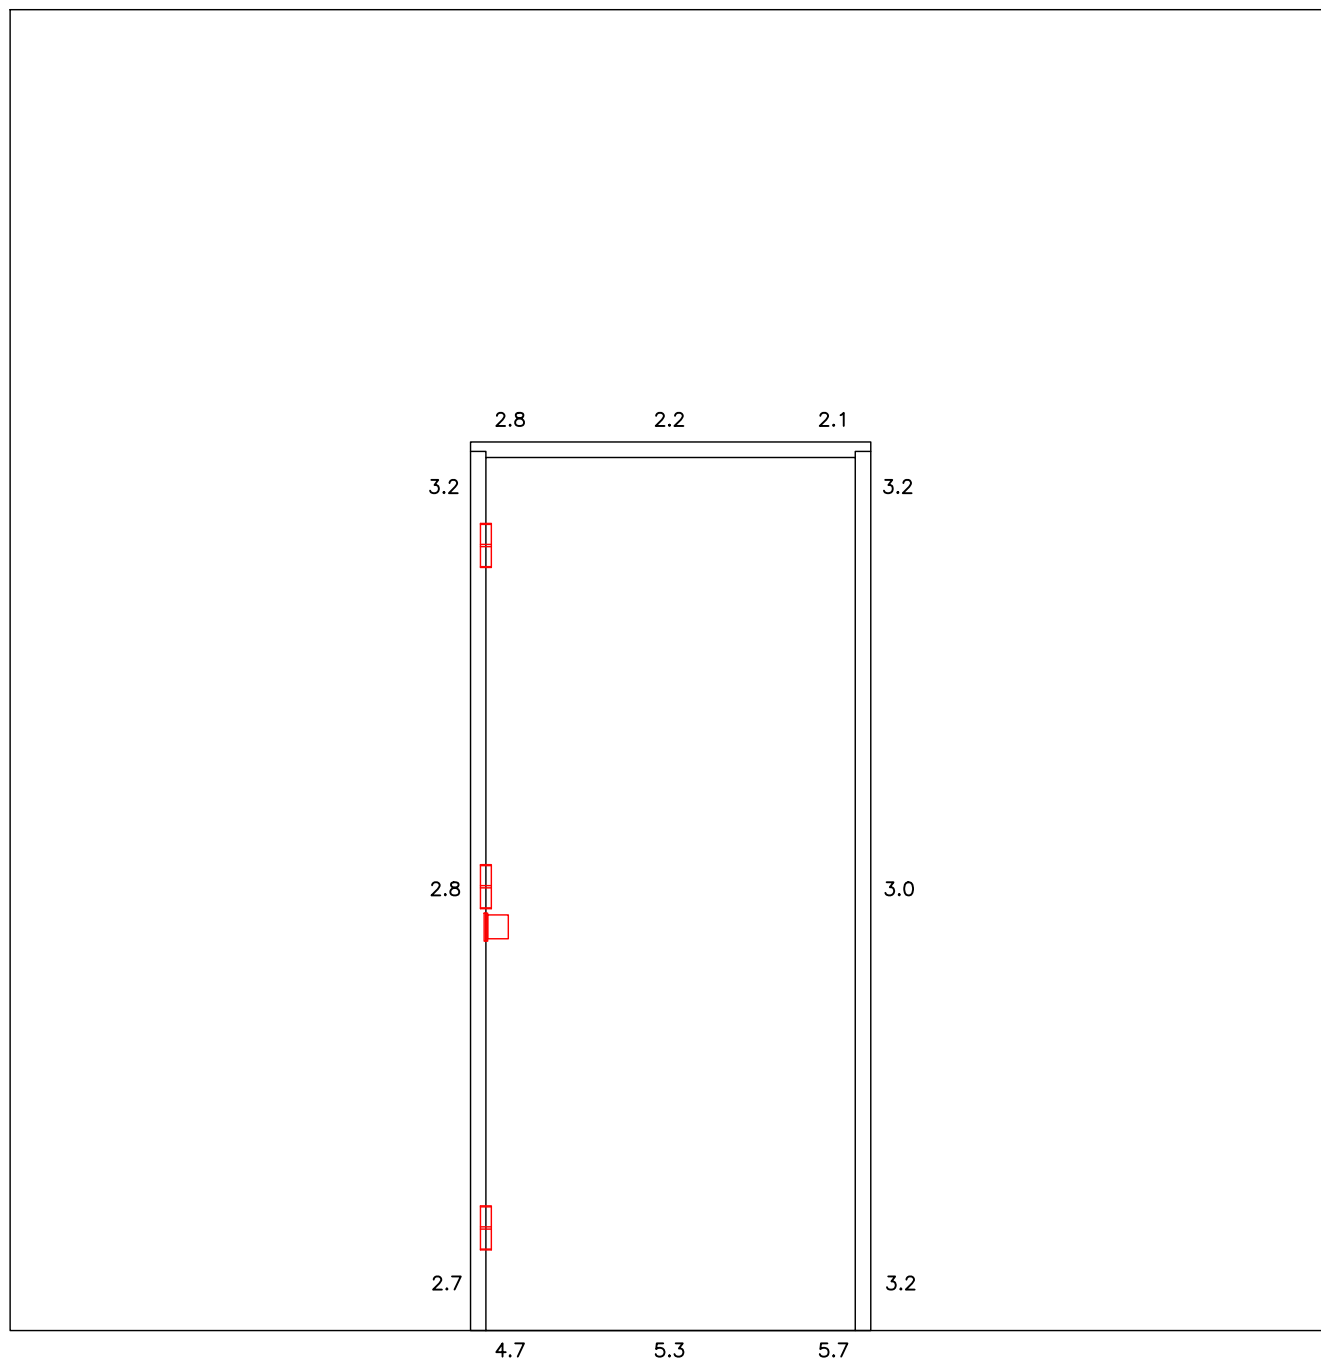
Gaps shown

Door leaves/frame gaps
(All dimensions in mm)

The manufacturer did not declare a working range so the door was installed to open and close freely, maintaining gaps, where possible, to a range of 2-4mm along all edges except the threshold, and 3-8mm along the threshold. The gaps between the edge of the leaf and frame were measured prior to test in accordance with BS EN 1634-1 2014, section 10.1.2. A total of 12 readings were recorded. The measurements (in mm) are detailed in Figure 5 of Appendix 1.

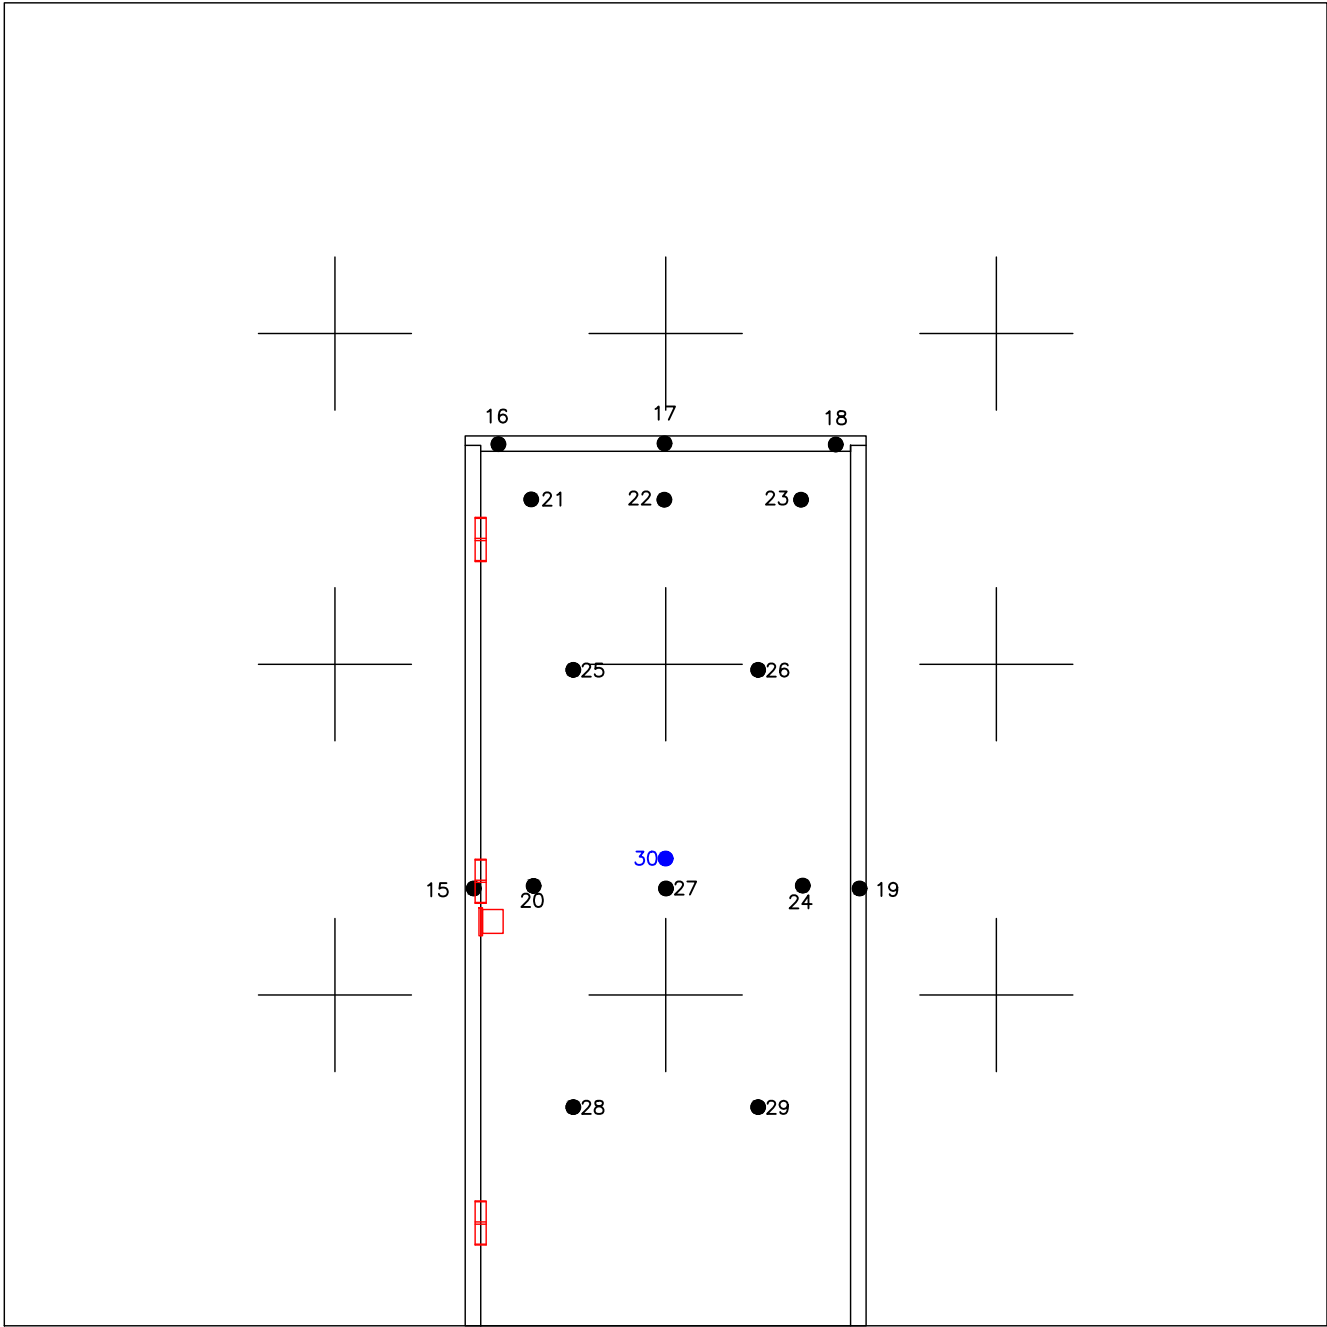
- ⊕ : Furnace Thermocouples
● : Unexposed Face Thermocouples
● : Radiometer

Title		
Thermocouple positions		
(All dimensions in mm)		
Date Drawn	Drawn By	Scale
16/11/17	ARD	NTS
Project No.		Appendix 1
WF 391562

(see Figure 6 of Appendix 1 for channel locations)
