**TEST REPORT NUMBER**  
**CFR1909171**

**FIRE RESISTANCE TEST**  
**IN ACCORDANCE WITH BS 476: PART 22: 1987**

**Sponsor:** Astra DC Limited  
**Address:** Unit 4, Astra business Centre  
Roman Way  
Preston  
PR2 5AP  
**Date of test:** 17<sup>th</sup> September 2019

A single leaf timber doorset,  
tested opening into the furnace as  
a latched, insulated doorset.

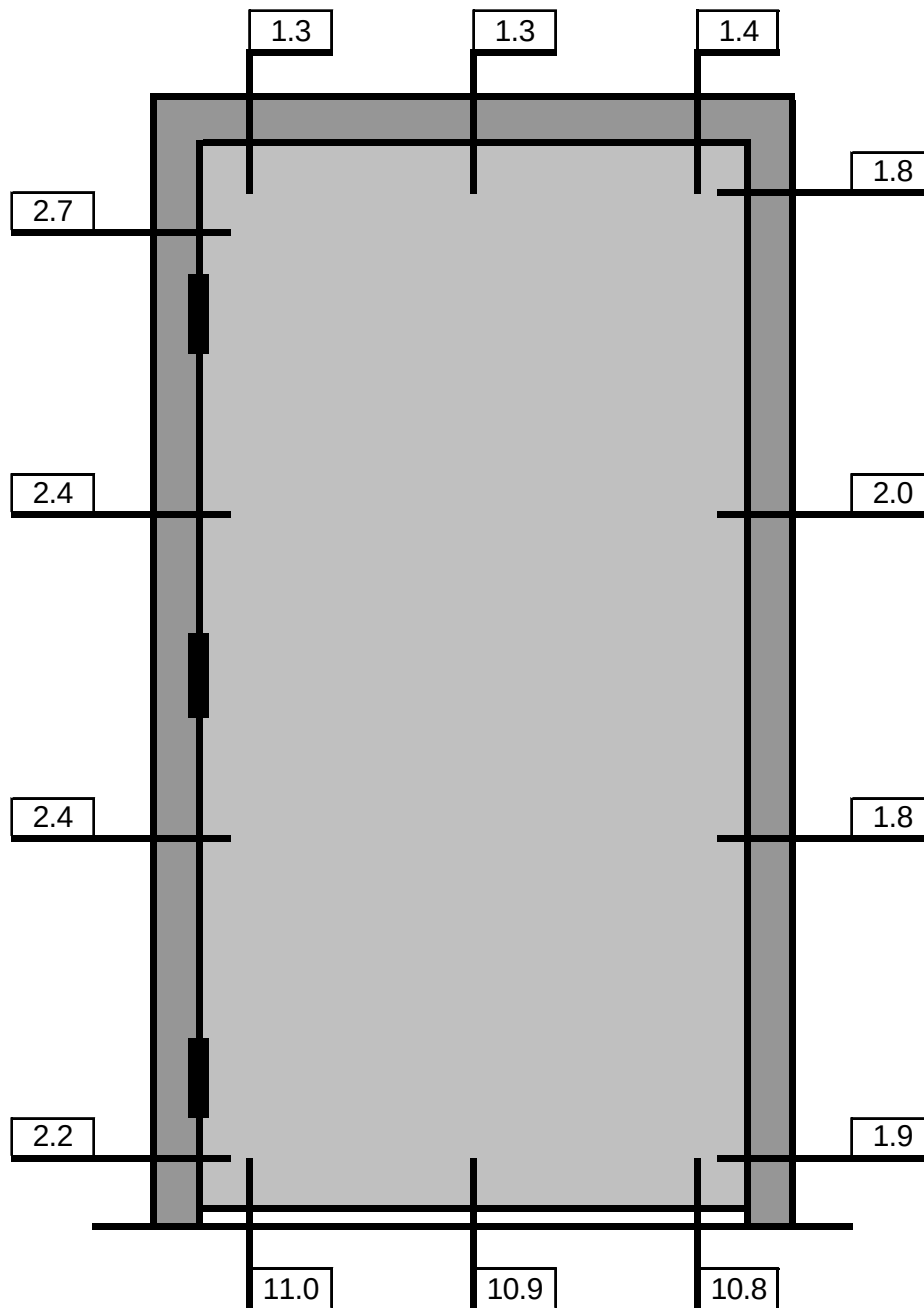
The gap between the leaf edges and the frame and at the threshold was measured on the exposed face prior to the start of the test. The following figure shows the position at which the measurements were made and the recorded gap (mm) at those positions.

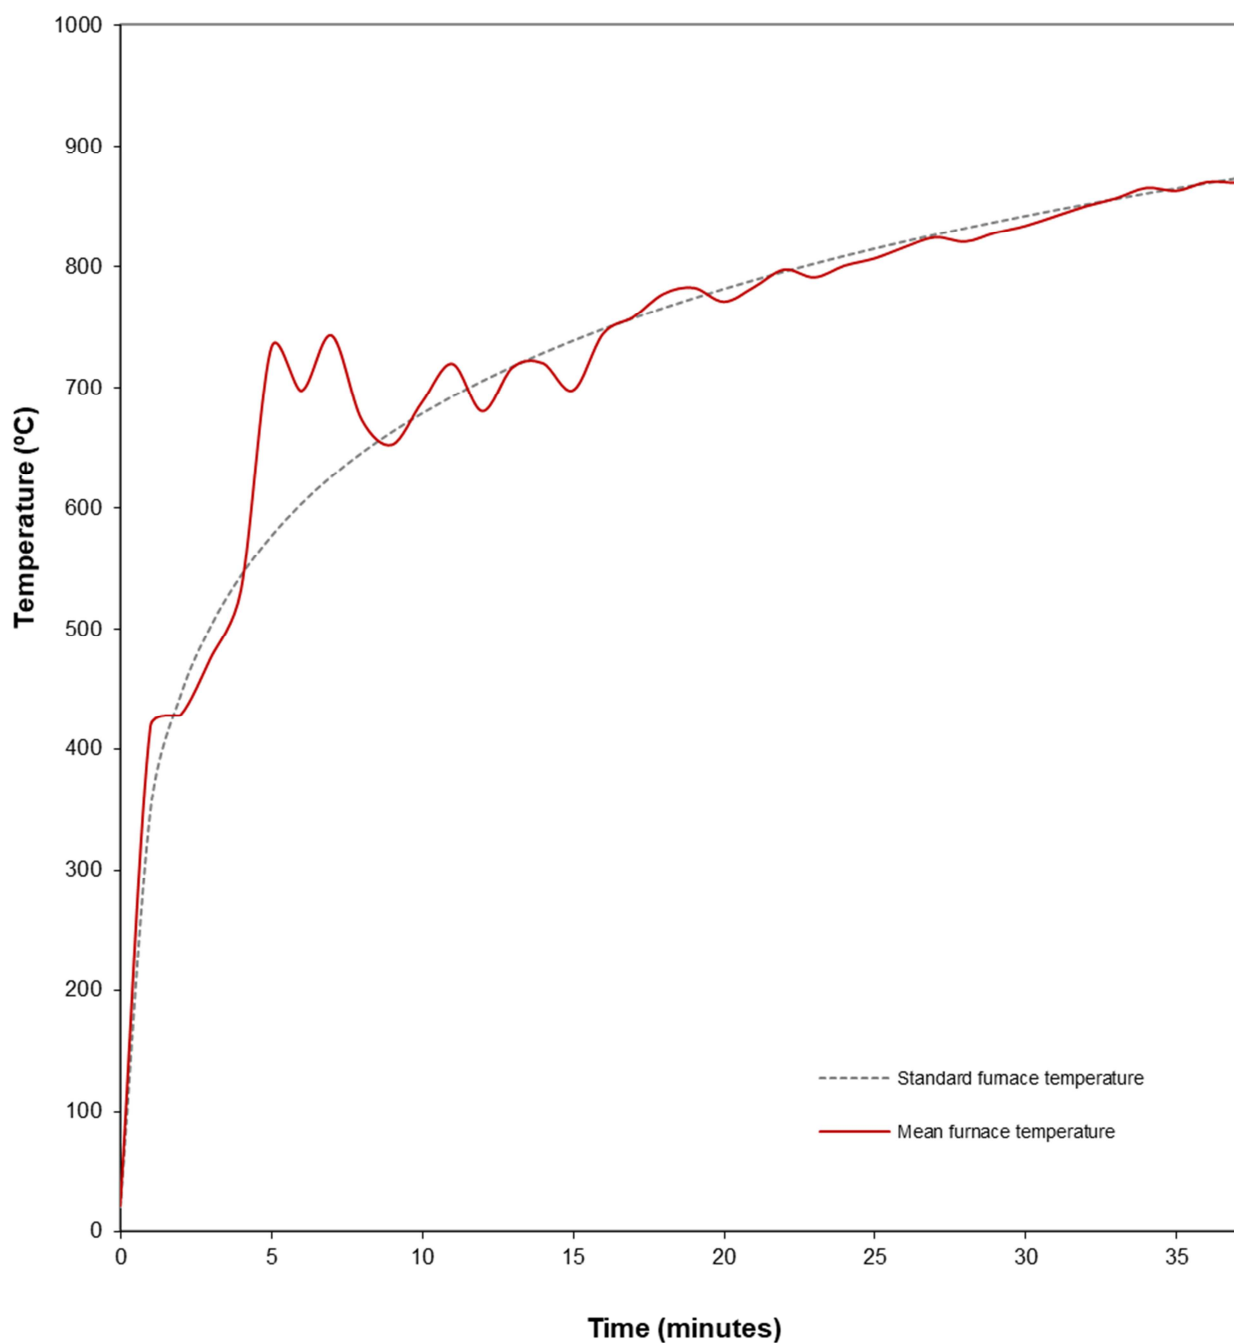
Furnace temperature was controlled so as to follow the standard temperature/time curve defined in the test standard and within the tolerances permitted. The furnace mean temperature was calculated from the output recorded using five furnace thermocouples of the design specified in the test standard. The following graph shows the standard and mean furnace temperature/time data.

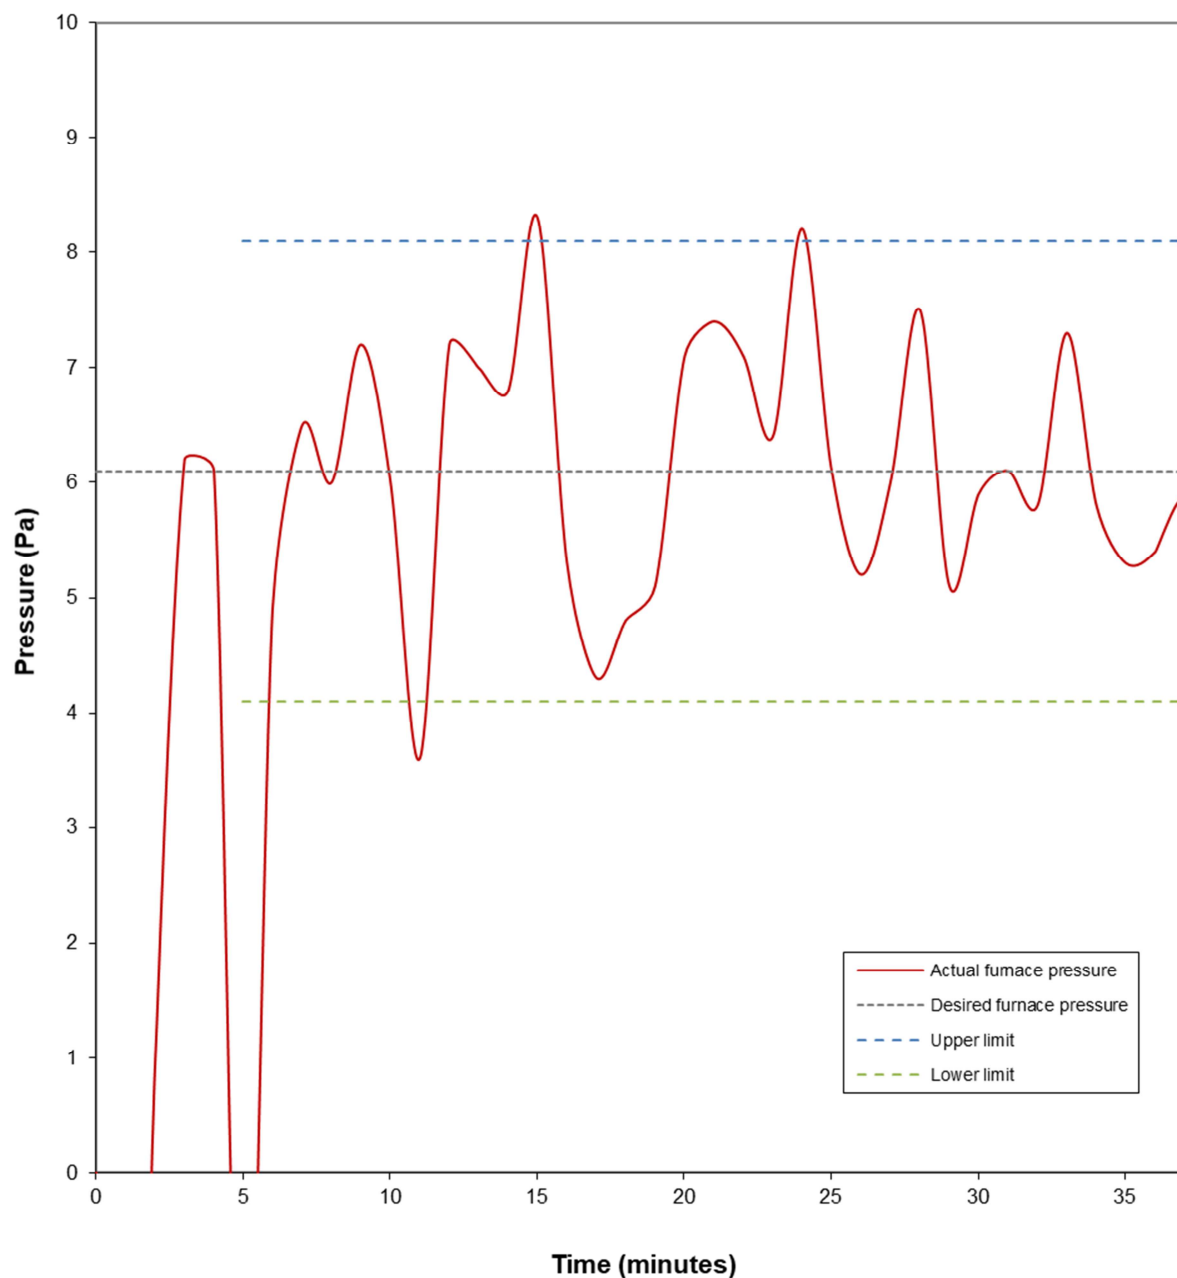
Furnace pressure was maintained for the duration of the test at a nominal + 6.1 Pa measured at the pressure sensing head. When a linear pressure gradient of 8.5 Pa/m is applied this equates to + 0 Pa at 1 m above the notional floor level. The furnace pressure was controlled within the tolerances permitted in the test standard except for 4 instantaneous occasions which were considered to be transient events. The following graph shows the actual and desired furnace pressure/time data.

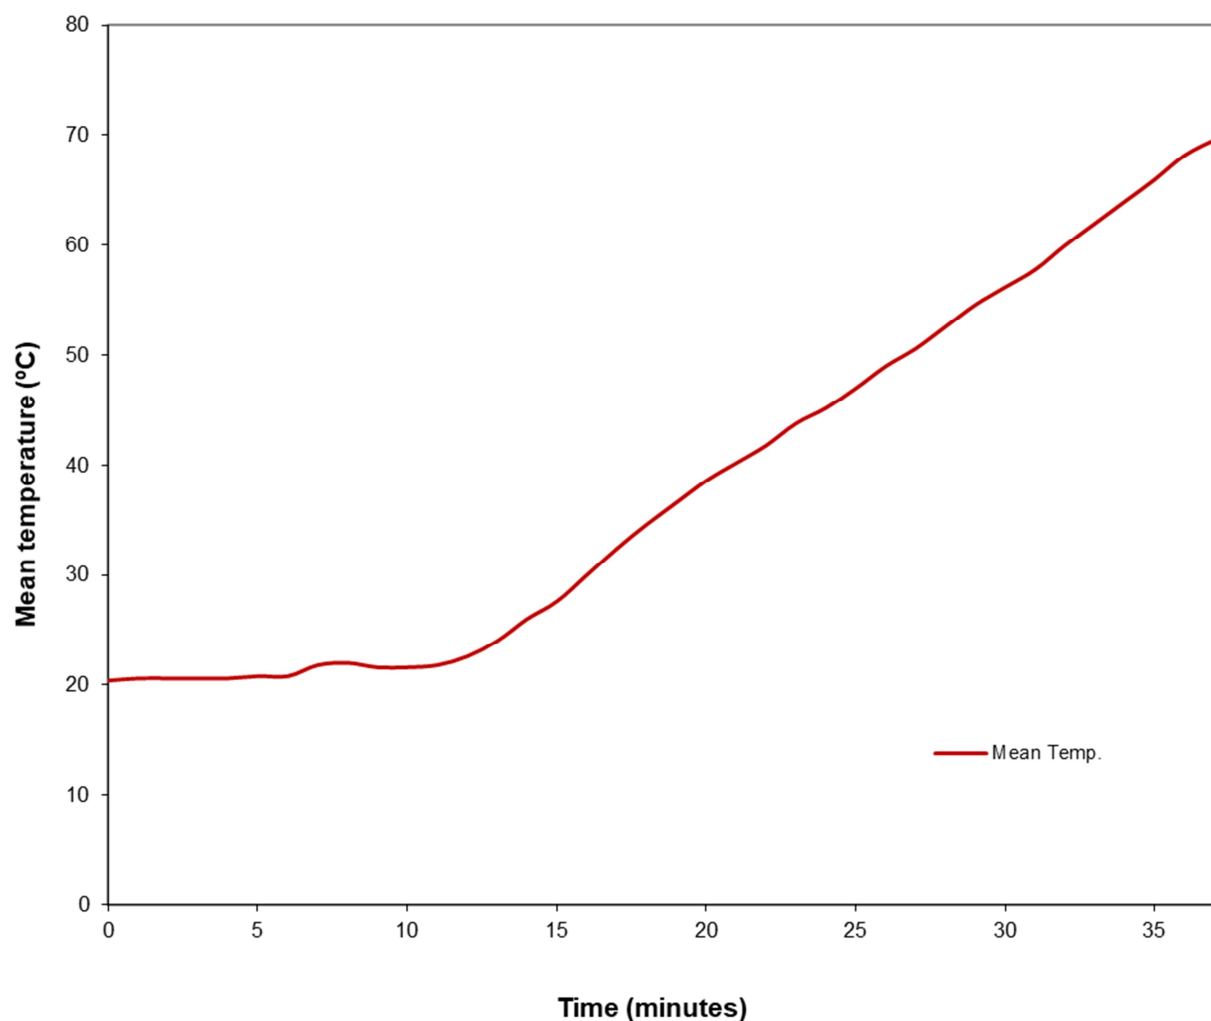
The following time/temperature graph shows the mean leaf temperature.

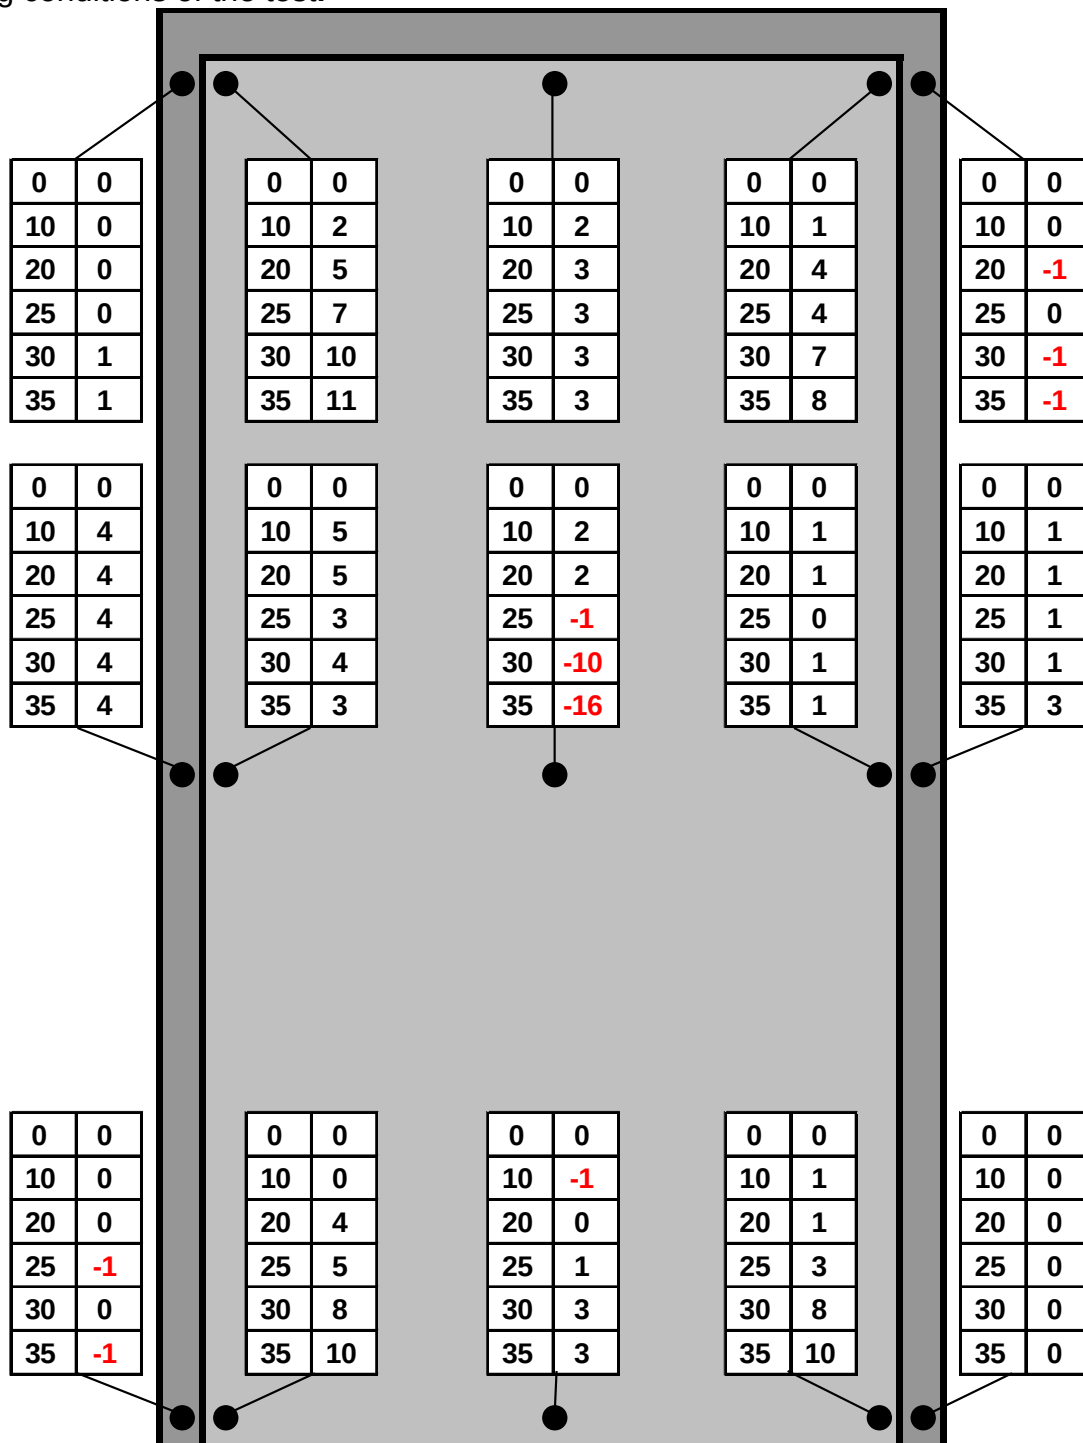
Taut stainless-steel wires were anchored horizontally across the unexposed face of the specimen such that any deflection experienced by the test specimen could be measured. One wire was positioned 10 mm vertically below the head of the leaf, the second at mid-height and the third 10 mm vertically above the threshold. The following figure shows these positions with the elapsed time (minutes) in the left-hand column and the recorded deflection (mm) in the right-hand column. Positive values indicate deflection towards the heating conditions of the test.

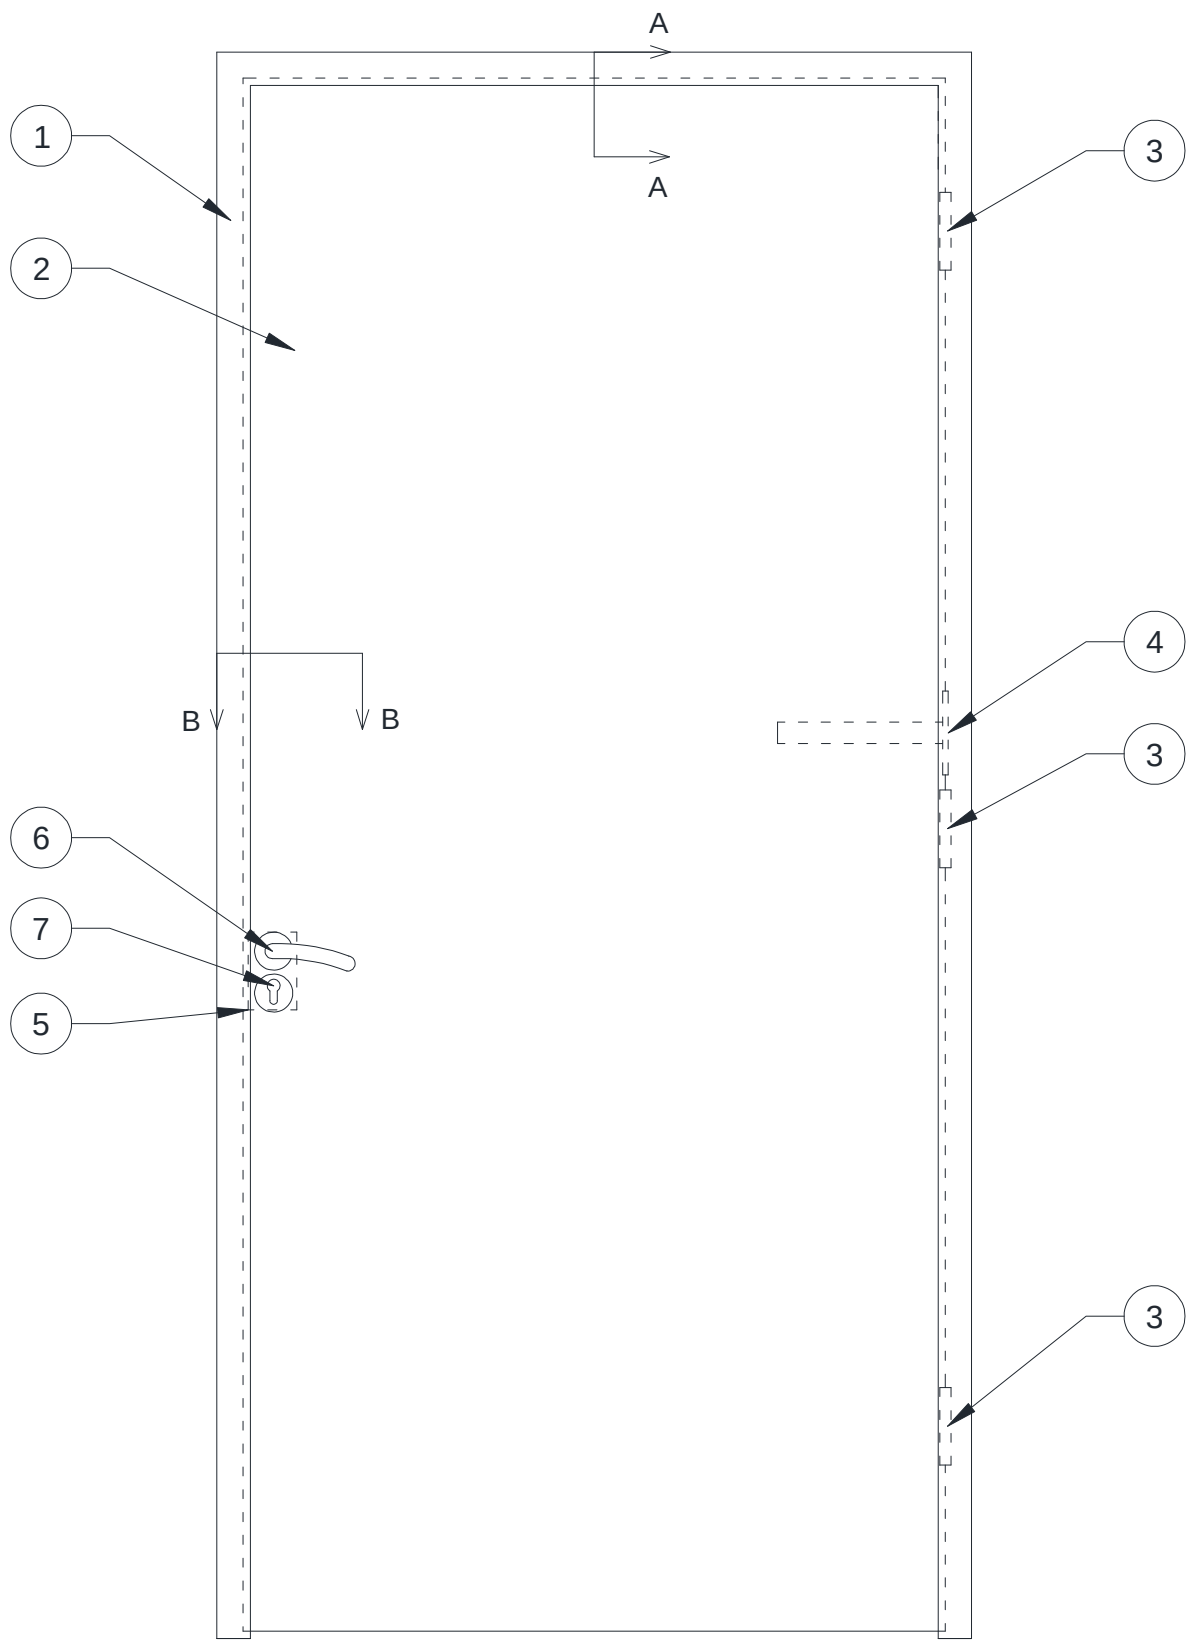
**Appendix 1 Figure 1 – Elevation viewed from unexposed face (inc. hidden detail)**

The item numbers listed in Appendix 1 Table 1 and shown in the figures in Appendix 1 refer to the components of the specimen construction. Any photo numbers refer to those in Appendix 2.

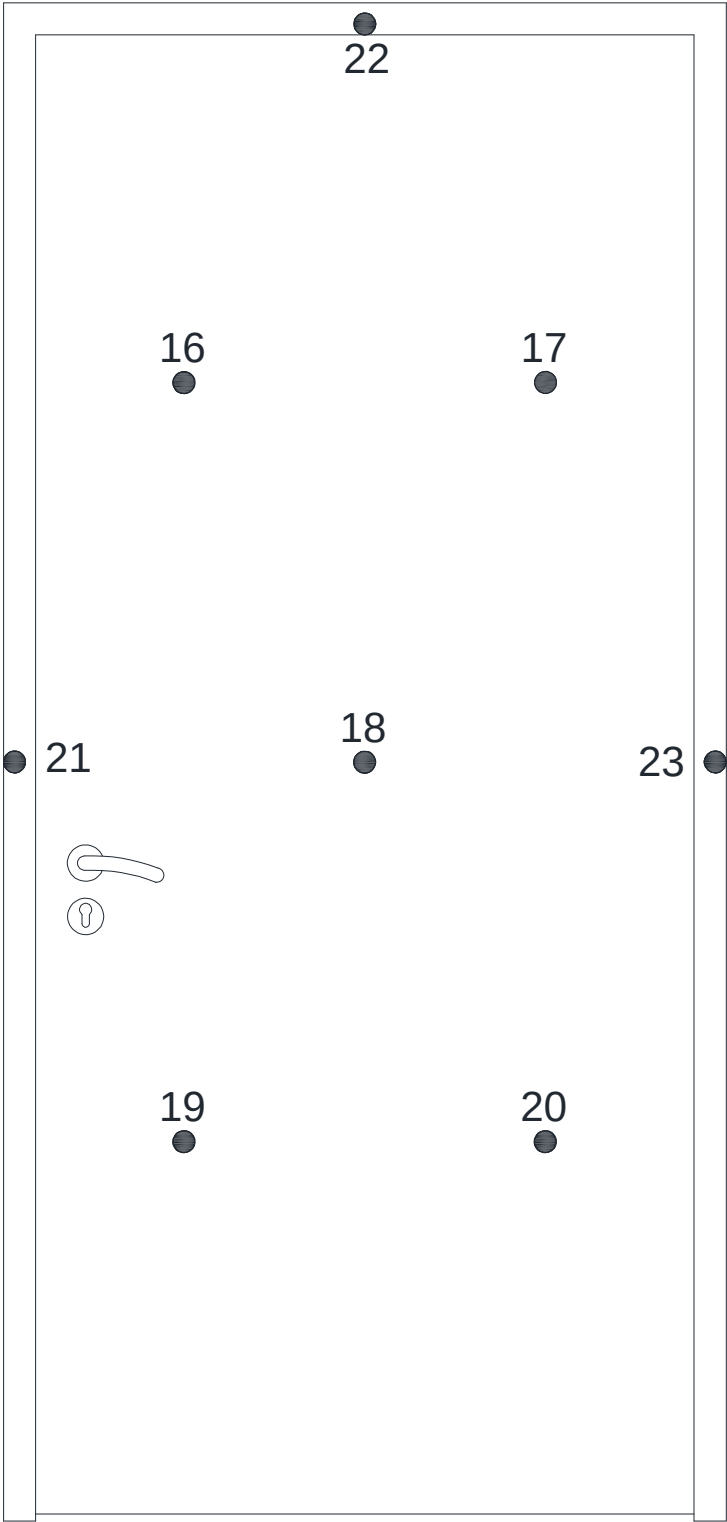
APPENDIX 3 POSITIONING OF INSTRUMENTATION

● Unexposed face specimen thermocouple

The positions of these thermocouples are shown in Appendix 3.
